HIGH TEMPERATURE ELECTRONICS TECHNOLOGY

LIFE TEST REPORT
FINAL REPORT - CDRL Item A003

MARCH 1985

GENERAL ELECTRIC

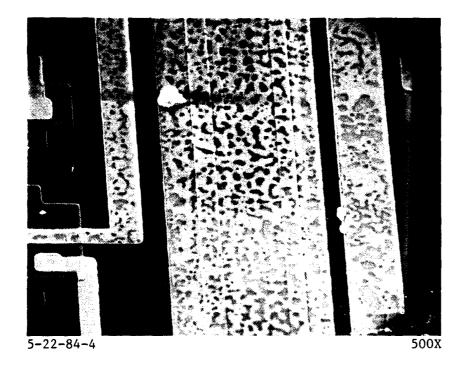
Figure 13. Closer View of Voiding in Sample 22-9.
